**PRELIMINARY ASSESSMENT/  
VISUAL SITE INSPECTION**

**THE EUREKA COMPANY  
BLOOMINGTON, ILLINOIS  
ILD 001 163 823**

**FINAL REPORT**

**U.S. ENVIRONMENTAL PROTECTION AGENCY  
Office of Waste Programs Enforcement  
Washington, DC 20460**

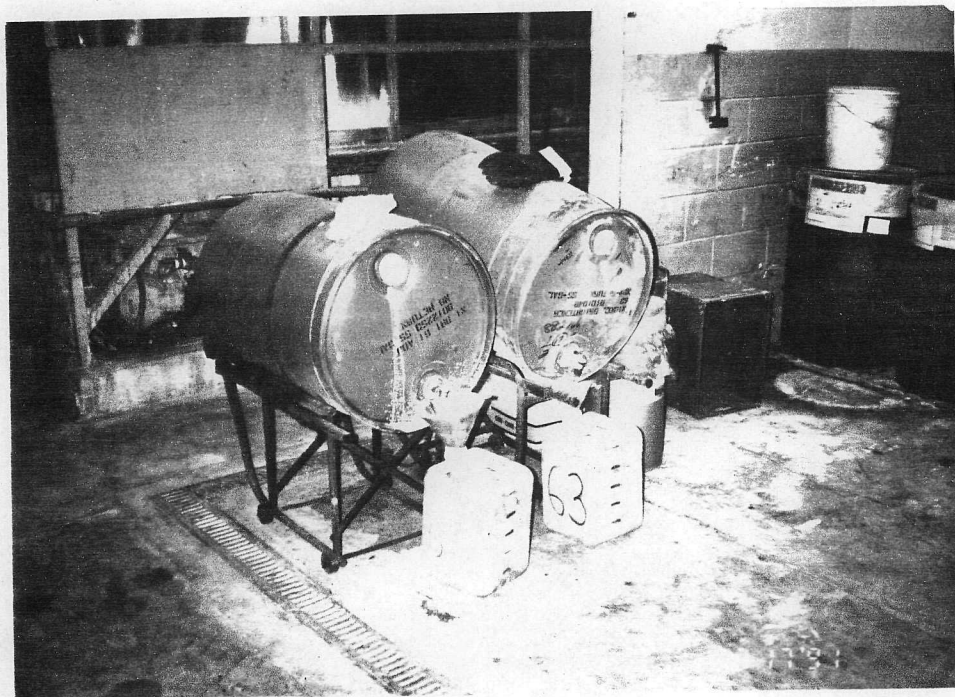
Location: SWMU 14 -- Building 6B  
Date: 7/17/91

<b>Wastes Managed:</b>	See the SWMU 12 wastes managed.
<b>Release Controls:</b>	This unit is located on concrete within the building. The three sumps have capacities of 800 gallons (chrome), 2,900 gallons (nickel), and 4,300 gallons (acid and alkali).
<b>History of Release:</b>	There have been no documented releases from this unit.
<b>Observations:</b>	This area appeared to be in good condition during the VSI. Drippings on the floor from metal parts were being collected with oil-dry. Facility representatives stated that the oil-dry was disposed of with oil separator sludge.
 <b>SWMU 14</b>	
<b>Unit Description:</b>	Tramp Oil in Alkali DSAA (Ni/Cr Lines 1 and 2)  A potassium hydroxide wash tank removes oil from metal parts before they are plated in Ni/Cr lines 1 and 2. The oil is removed from the alkaline solution by a centrifuge, and the waste, "tramp oil in alkali," is collected in a 55-gallon drum in this unit (see Photograph No. 13).

Photograph No. 13  
Orientation: East  
Description: Tramp oil in alkali DSAA.

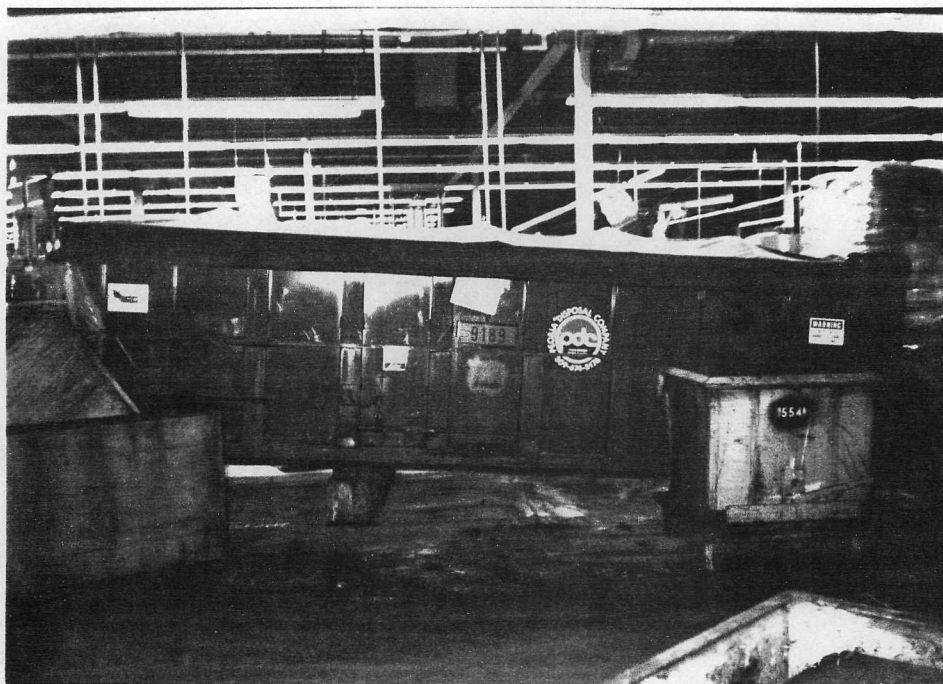
Photograph No. 20  
 Orientation: West  
 Description: Plating sludge roll-off box.

Location: SWMU 19 -- Building 6C  
 Date: 7/17/91

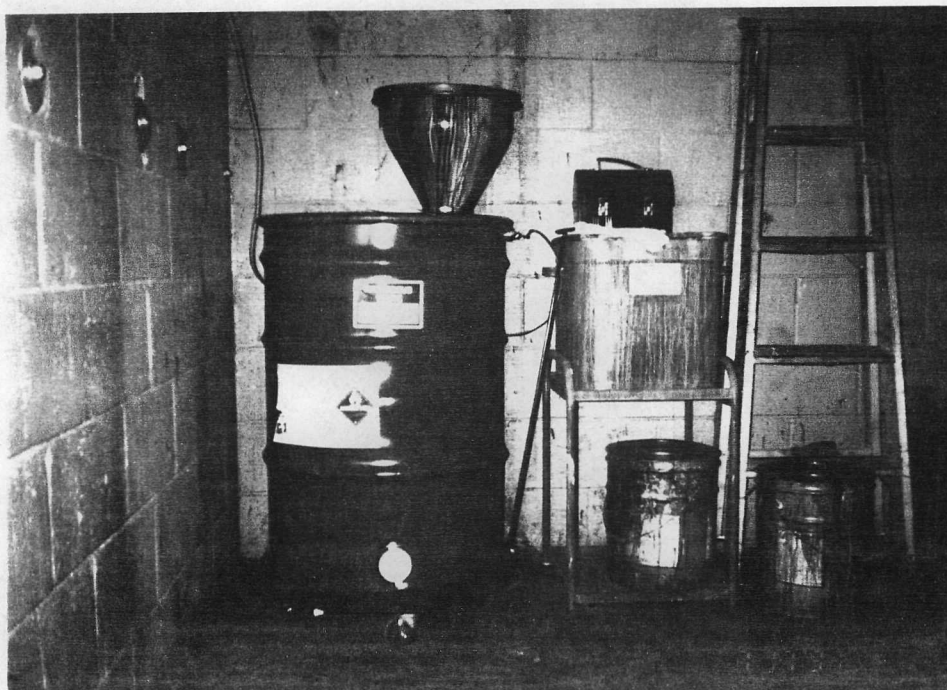
Photograph No. 30  
 Orientation: East  
 Description: Paint spray room DSAA.

Location: SWMU 30 -- Building 1 Paint Shop  
 Date: 7/17/91

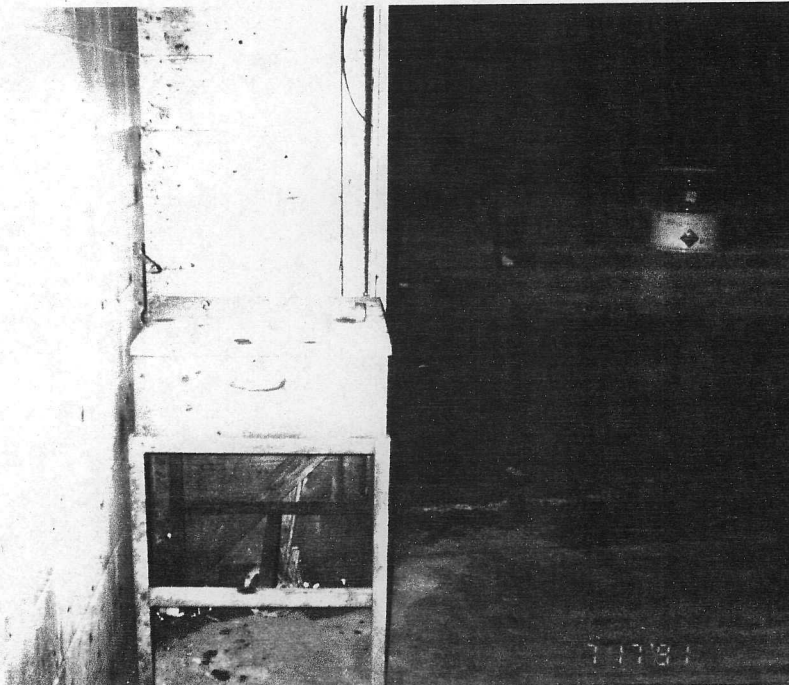
Photograph No. 34  
Orientation: East  
Description: Stoddard solvent parts cleaner.

Location: SWMU 33 -- Building 3  
Date: 7/17/91

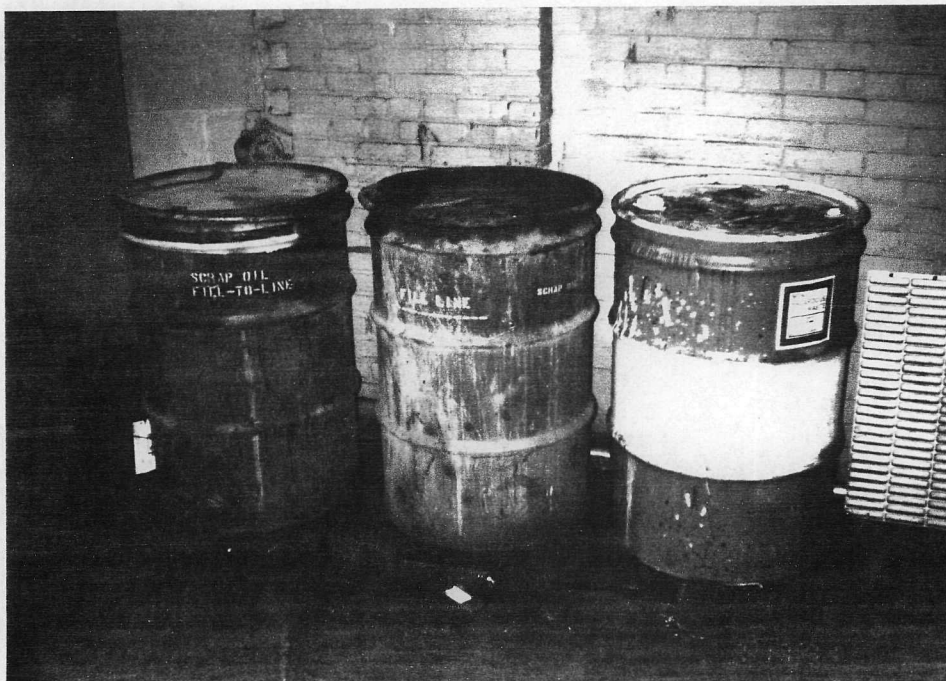
Photograph No. 37  
 Orientation: West  
 Description: Waste oil storage drums.

Location: SWMU 35 -- Building 5E  
 Date: 7/17/91

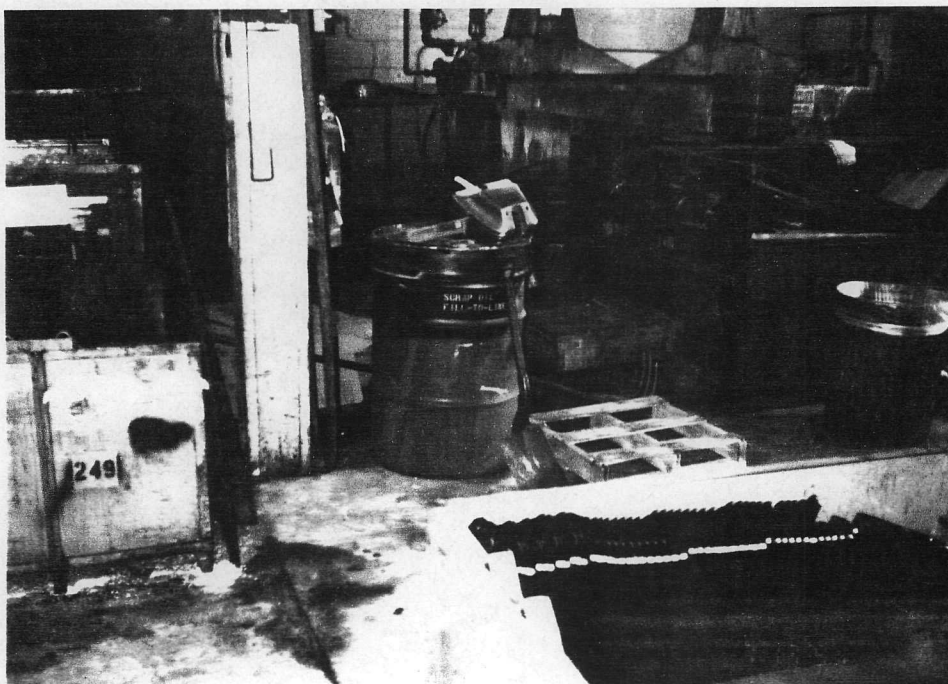
Photograph No. 38  
 Orientation: North  
 Description: Waste oil collection drum for paint strip area.

Location: SWMU 38 -- Building 7T  
 Date: 7/17/91

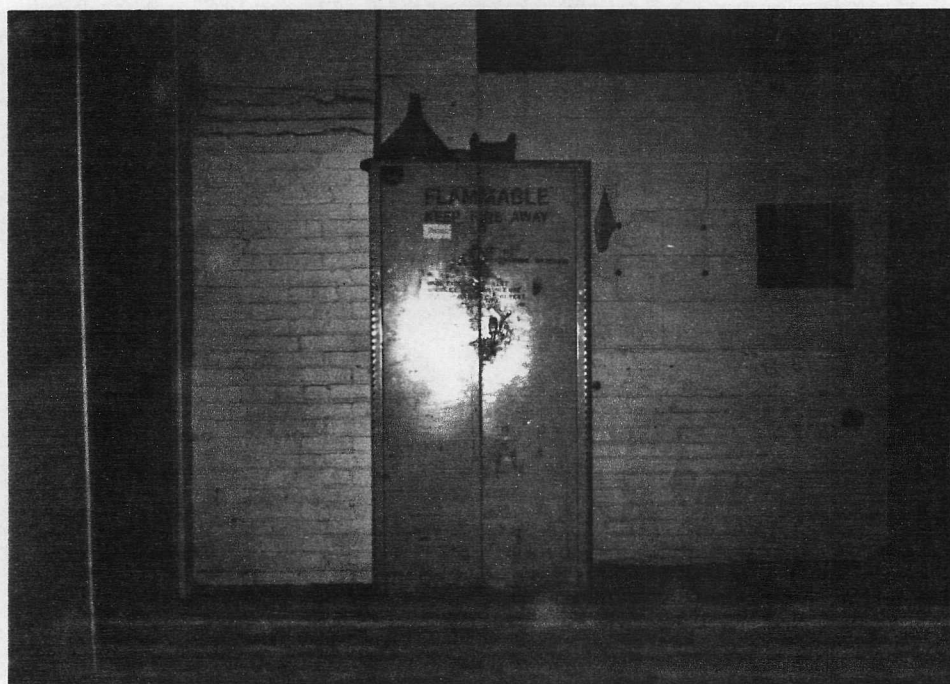
Photograph No. 44

Location: SWMU 44 -- Building 2T

Description: Old paint spray room waste cabinet for Plant 2 spray booths.

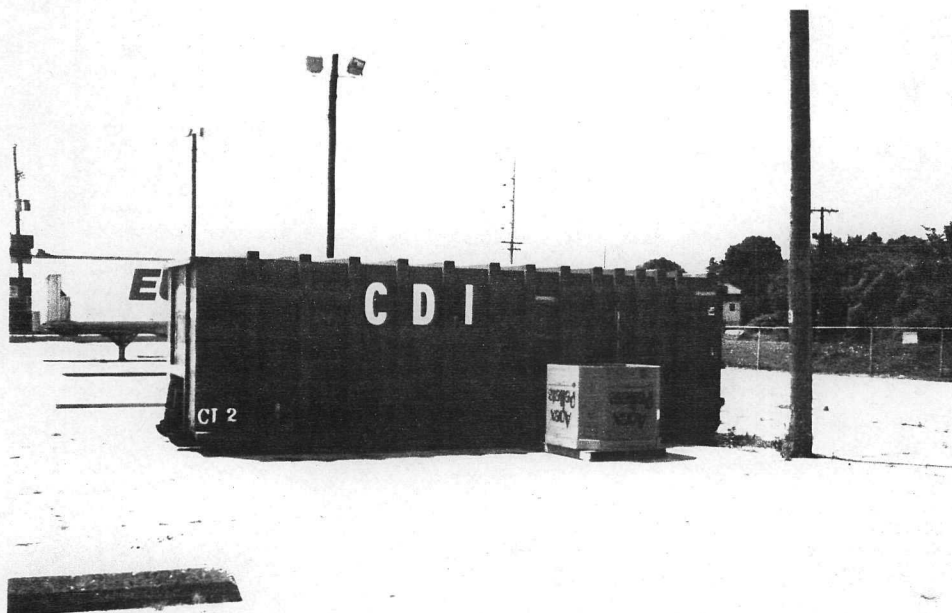
Photograph No. 47  
 Orientation: Southeast  
 Description: Nonhazardous waste roll-off box.

Location: SWMU 47  
 Date: 7/17/91
